K.E. McCartney & Associates, Inc.

Sewer System Evaluation Survey (SSES) Services

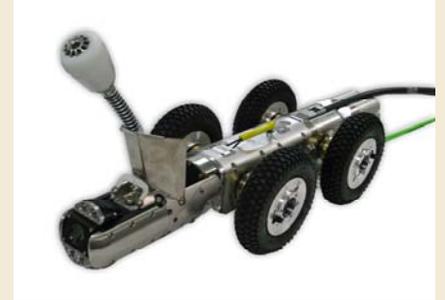
Mainline/Lateral Inspection Camera

KEM's CCTV Truck

To provide the most complete services possible, KEM's CCTV Truck is equipped with the following:

- OZII mainline camera to televise 6" through 30" mainline sewers
- LAMP11 lateral camera to televise 3" through 8" sanitary laterals from the mainline
- MP2020 push camera to televise laterals from a cleanout
- Rigid SR-20 to identify the location and depth of mainline and lateral sewers
- Trimble GeoExplorer 6000 series handheld GPS unit for GPS data collection
- Data supplied on DVD's or thumb drives based on the customers preference

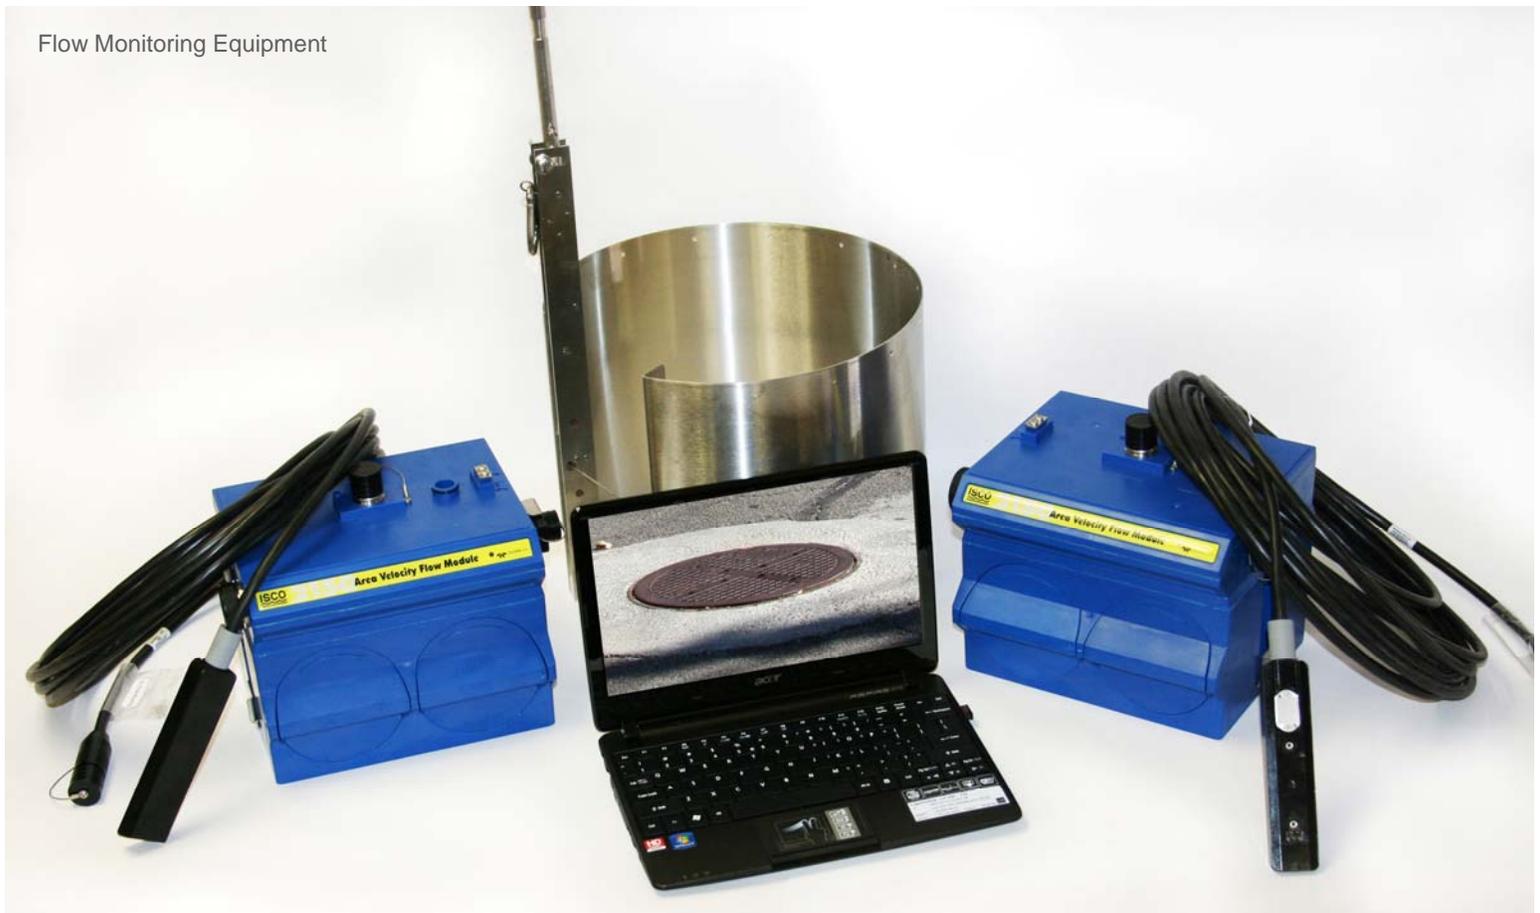
One of the first steps in any successful SSES is to perform flow monitoring. This flow data can be utilized to either determine if there is sufficient capacity for service expansion or to identify areas with high levels of I/I.

Flow Monitoring Equipment

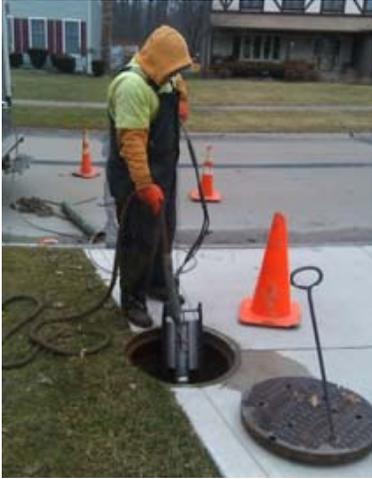
CCTV Utilized During Dye Testing

KEM performed an I/I study for the Olmsted Township area in Cuyahoga County to determine where excessive flows are entering the sanitary sewers in this 1,200 home subdivision. It was determined that excessive I/I was entering the sanitary sewers in an area of the subdivision that was built in the 1950's which utilized a common trench for the storm and sanitary sewers. Alternatives for lining or replacing the existing sanitary sewers were developed to determine the best option for remediation. As part of the project, a sanitary sewer model was developed to analyze the effect of remediation efforts on the entire system.

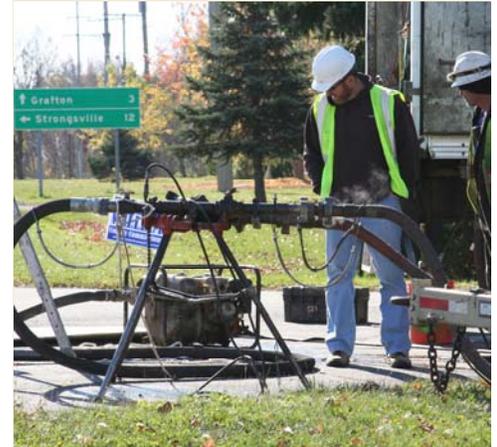
Brentwood CIPP Lining
